IMS Bearing Service: Prequalification of Your Engine

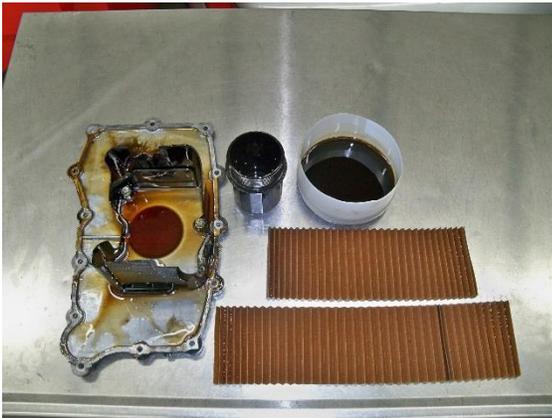
Here, we are performing the inspection of the oil, oil filter and housing, and sump cover. We look for and assess any metal flake and debris that may be present.

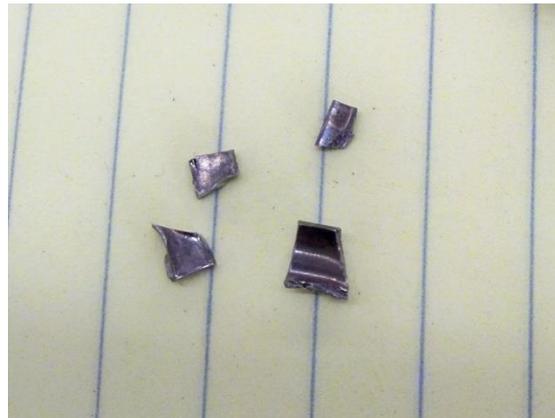
These pieces of metal were discovered in a customer's sump cover after it was removed for inspection. They are pieces of the IMS bearing cage and part of a timing chain roller, and had cycled through the engine's oil system. Unfortunately, this engine had been compromised even though the IMS bearing had not completely failed yet. The engine will need to be disassembled and fully inspected for any further damage caused by the circulation of this and any other debris.
