## Window Seal Rust: Cause and Prevention

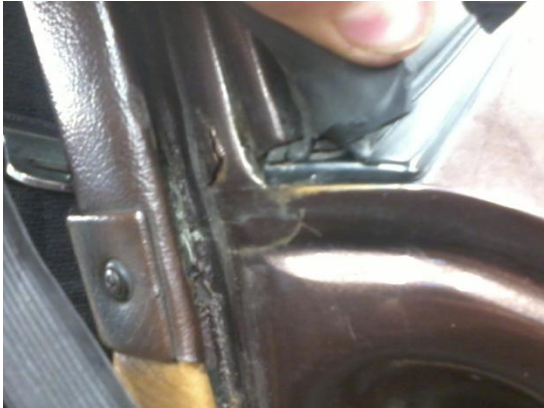
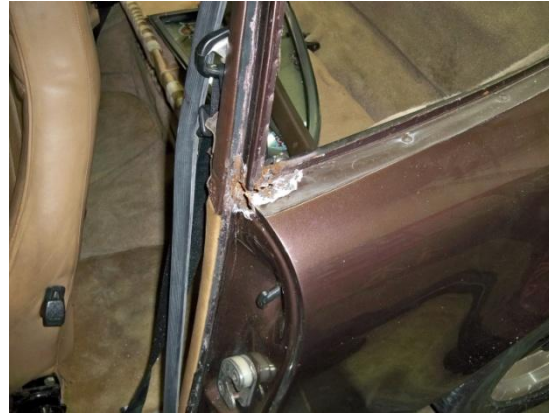
Pictured here is the driver quarter window on this 1983 911SC. As you can see, the rust did not look too bad at first glance on the left; however, upon further inspection, the damage was much worse than how it originally appeared.

Over time, the seals become hardened and shrink, allowing moisture to gain access under them. This moisture potentially leads to rust problems in your Porsche.

Prevention simply involves replacing your old, hard window seals.

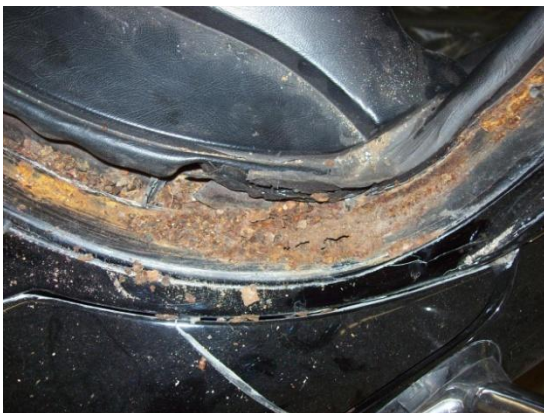
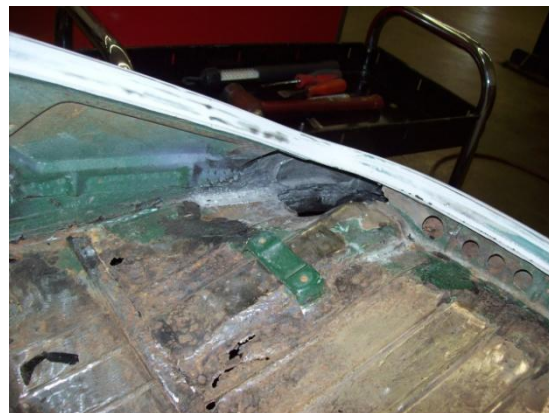
Pictured above is the result of not replacing old front and rear windshield seals.
